MEMORANDUM

October 5, 2016

SUBJECT: Public hearing and consideration of a demolition permit application for the house located at 2334 14th St., a non-landmarked building over 50 years old, pursuant to Section 9-11-23 of the Boulder Revised Code (HIS2016-00191).

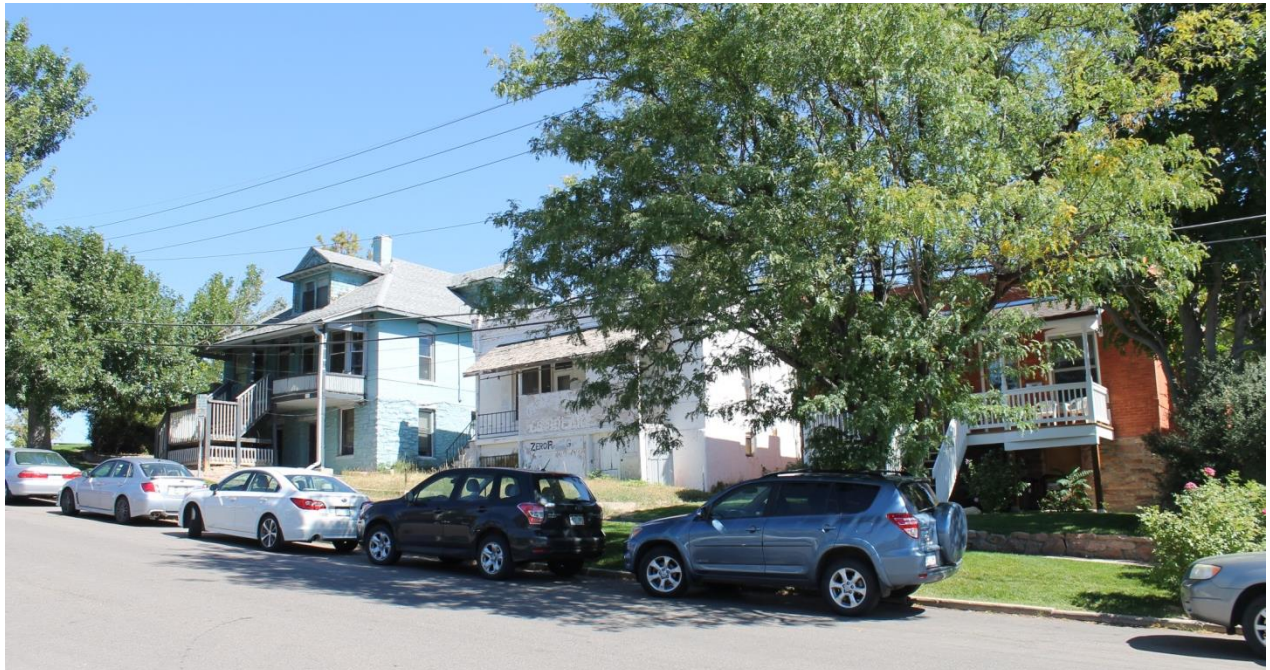
2338, 2334, and 2330 14th St., 2016.

In large, the house at 2334 14th Street is intact to its historic construction as evidenced in the c.1900 photograph (Figure 8). The most obvious changes to the building from this view are alterations to the front porch including relocation of the stair from the front, removal of the denticulated porch gable, and removal of decorative railing barge boarding.

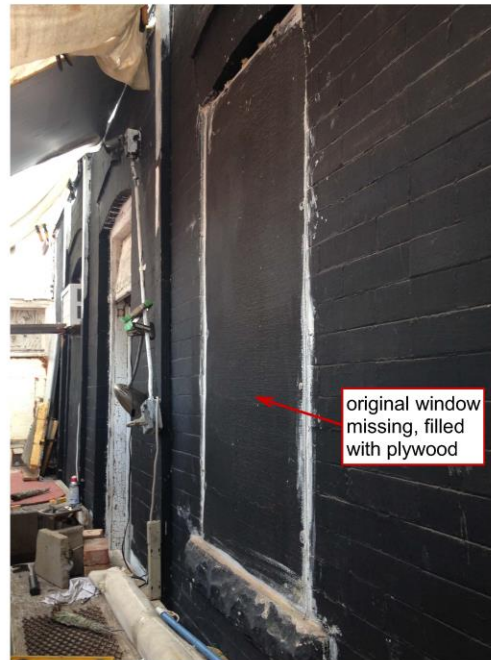
photo 13: window

photo 13: brick not plumb or level
